Recreational Boat Collision Accident Research

Volume 1

Miles A. Beam III, P.E.
Senior Project Engineer
Marine Department

Underwriters Laboratories Inc.

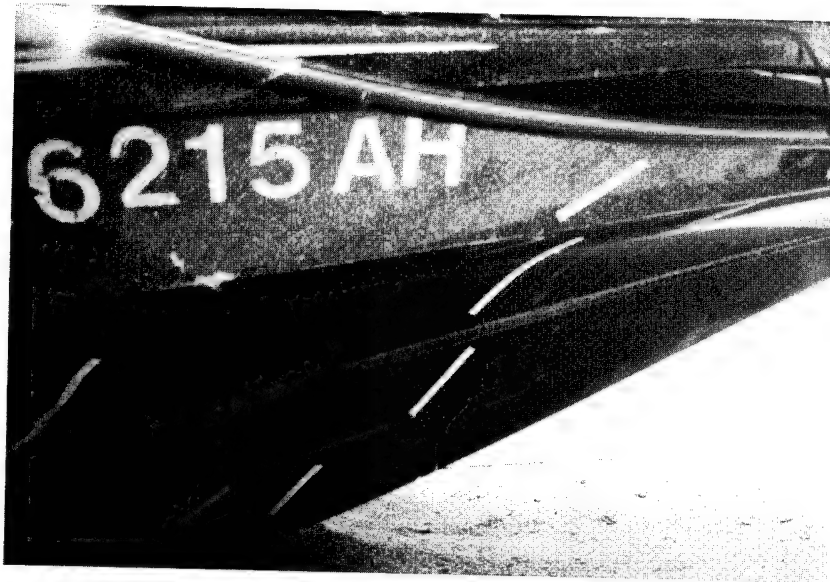
The most important data obtained from the bullet boat was the striations which were left on the bottom of the forward half of the hull. Most of the striations were located on the starboard side of the bullet boat hull. A few small ones were located on the port side near the bow. Figure 13-1 and 13-2 show the striations. Since many of the striations were light, and would not show up on film, masking tape was placed next to the longer and deeper striations in order to ensure that the direction of these scratches was documented. The distance of the striations from the front of the boat was noted so that they could be properly located on a damage diagram. Figure 13-2 shows where two chunks of fiberglass were removed from the spray rails. This type of damage is typically caused when the bullet boat bottom catches a deck cleat, hand rail, or other hard metal object. Often the object on the target boat which caused this damage can be located and identified. It was especially significant that no striations could be found on the rear half of the bullet boat hull bottom. Figure 13-3 shows the striations as documented on the bullet boat.

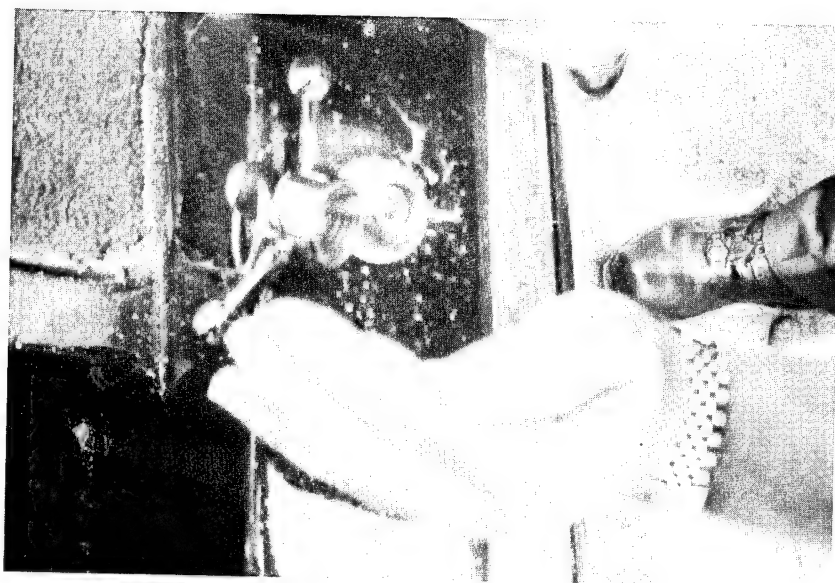
Figure 13-4

A cleat located on the starboard side near the bow had fiberglass fragments wedged underneath it as shown in Figure 13-4. One piece of the fiberglass contained a color which was only found in a decal located on the rear of the other boat.

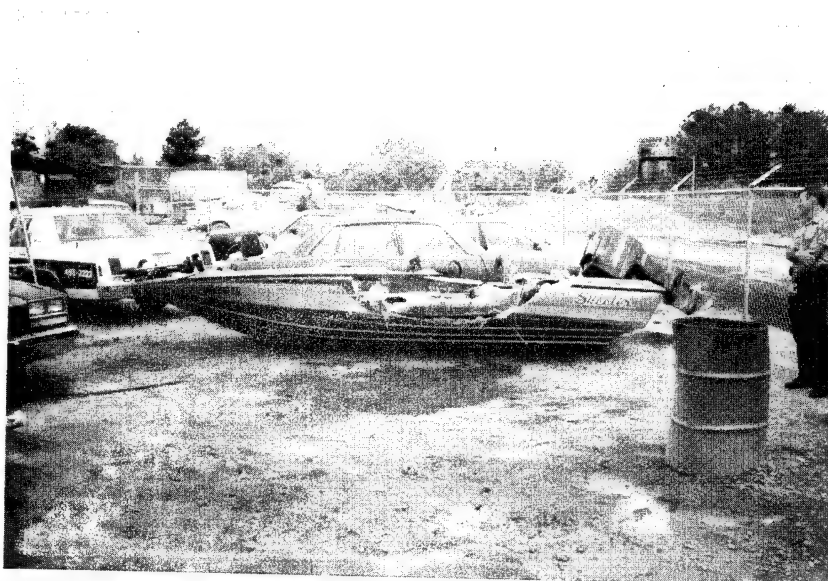
Figure 13-5 shows the target boat and the damage to the port side. Figure 13-6 shows the bullet boat, which suffered only relatively minor damage. Numerous small pieces of information were assembled to formulate a hypothesis for an impact angle. The damage diagram for the target boat is shown in Figure 13-7. In addition to the damage to the hull side, impact damage was noted on the steering wheel, the depth finder forward of the steering wheel, the passenger seat, and the top of the outboard motor housing. The depth finder seems to have experienced a glancing blow, while the steering wheel was impacted by something solid. Other components were damaged; however, those mentioned provided the best data for a reconstruction.

A close look at the leading edge of the damage to the port side shows that the penetration angle of the hull side was at an angle, and not straight on. Note that this alone would not rule out an impact angle of 90 degrees; however, for this damage to occur, the target boat would have had to have significant speed when compared to the bullet boat. In other word, it is not possible to create this type of damage during a 90 degree impact if the target boat is stationary or moving very slowly.

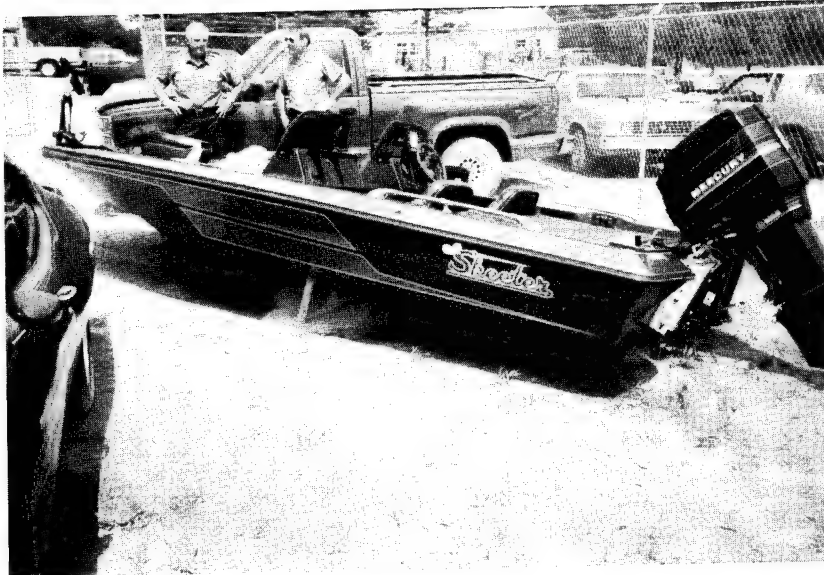
Figure 13-6

Damage to the bullet boat, shown in Figure 13-6, was relatively light. The hull appeared to have nearly severed from the deck cap, especially at the forward part of the boat. The hull had even cracked at the gunwale about half way back on the starboard side. This damage could have been caused by contact with the target boat during the collision. It could also have been caused another way. If the boat rolled severely to starboard while airborne, it could have landed on its side when it re-entered the water. This type of rolled attitude re-entry has been known to

cause separation of the hull and deck joints during earlier experimental collisions. Stress cracks all along the hull side may also be visible from extreme flexing of the hull side which also may occur during re-entry into the water. There was not sufficient information to determine if the boat rolled as a result of the collision.

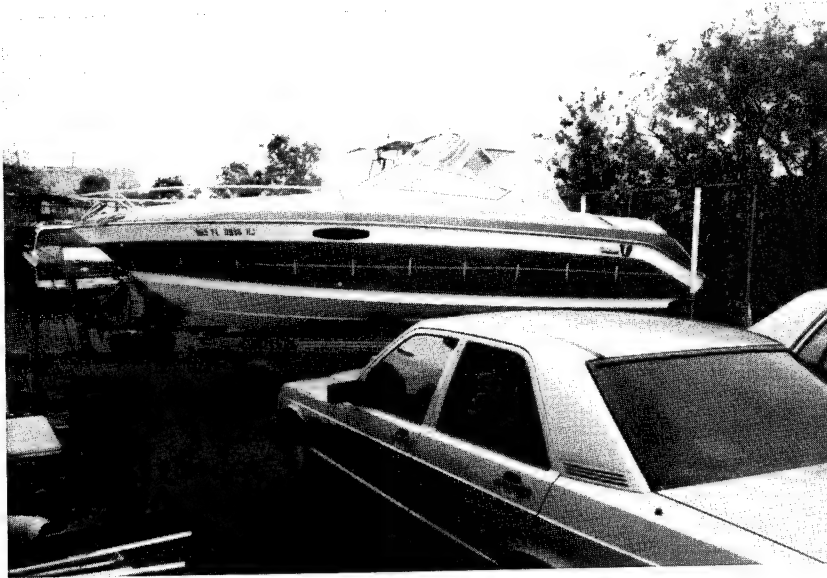
Figure 13-12

The accident happened near shore, and both boats rested in shallow water among a group of mangroves. The mangroves caused additional damage to the boats, especially to the cruiser. Figures 13-12 and 13-13 show overall views of the cruiser and ski boat respectively.

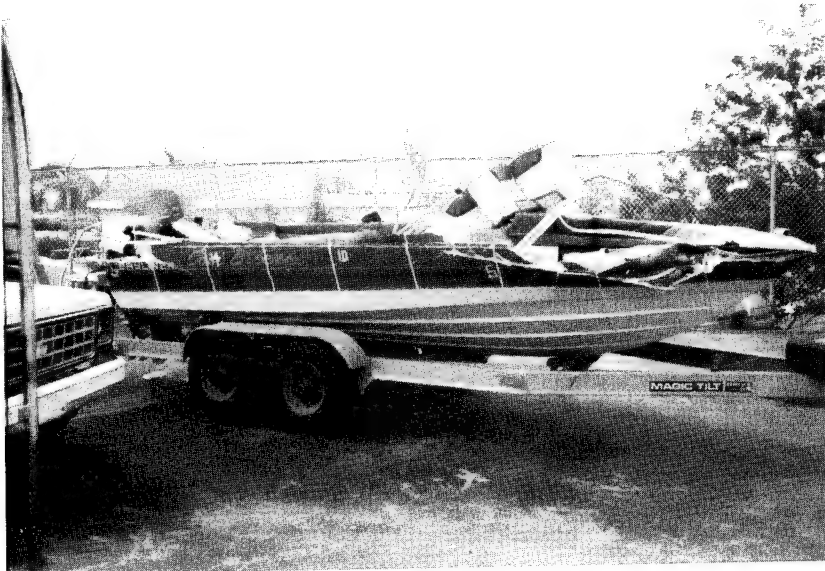
The damaged area on the starboard bow of the target boat shown in Figure 13-13 is believed to be the initial impact area. The notch in the forward most part of the "V" shaped section is likely where the bow hook of the bullet boat passed through. Dimensions

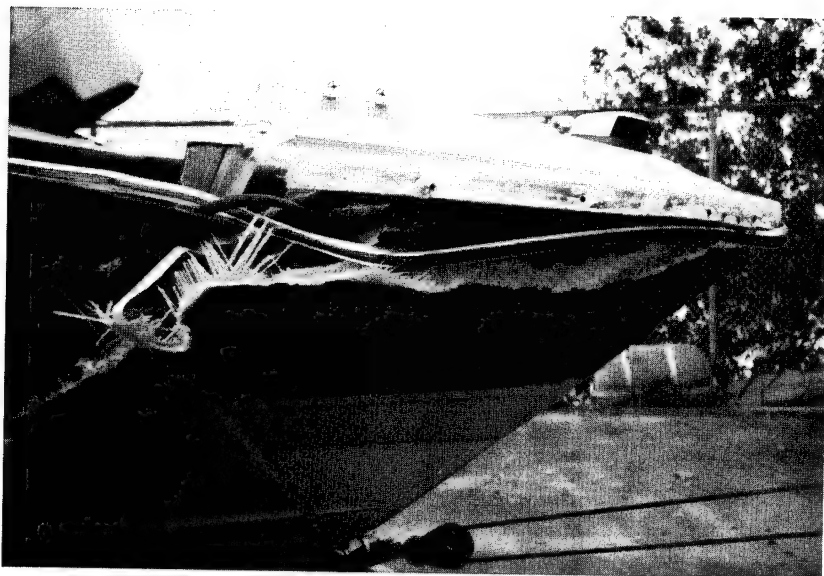
Figure 13-14

The starboard bow was badly damaged. A large vee shaped cut was carved into the hull. The forward edge of the vee shaped cut-out was a notch shaped cut as shown in Figure 13-14. This notch was believed to have been from penetration of the bow hook on the bullet boat.

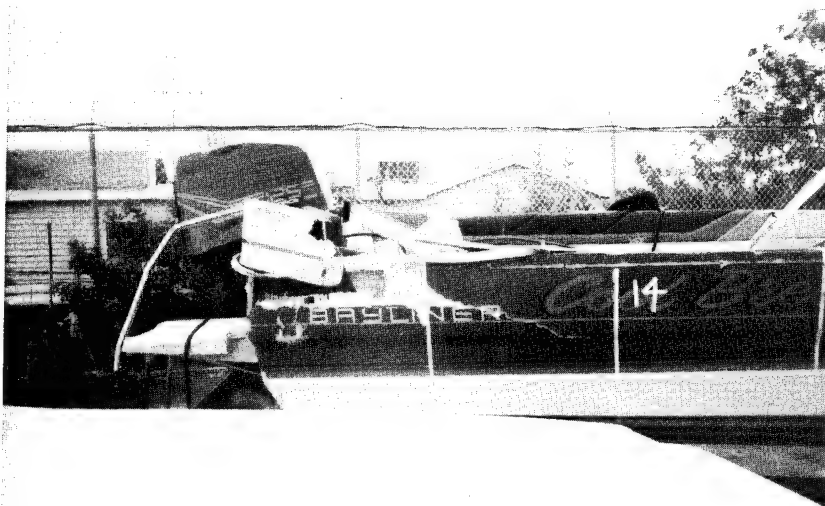
Damage to the starboard rear quarter near the stern as shown in Figure 13-15 may have been the area where the outdrive impacted; however, investigators informed UL that rescuers on the scene had to literally cut part of the ski boat out of the way in order to get to occupants trapped in the wreckage. Without knowing any more details of what was cut away, it was difficult to distinguish between impact damage and damage caused by the rescuers. The most forward edge of the area of the corner appears as though it may have been impact damage. The horizontal cuts adjacent to it are much cleaner as though a saw had been used.

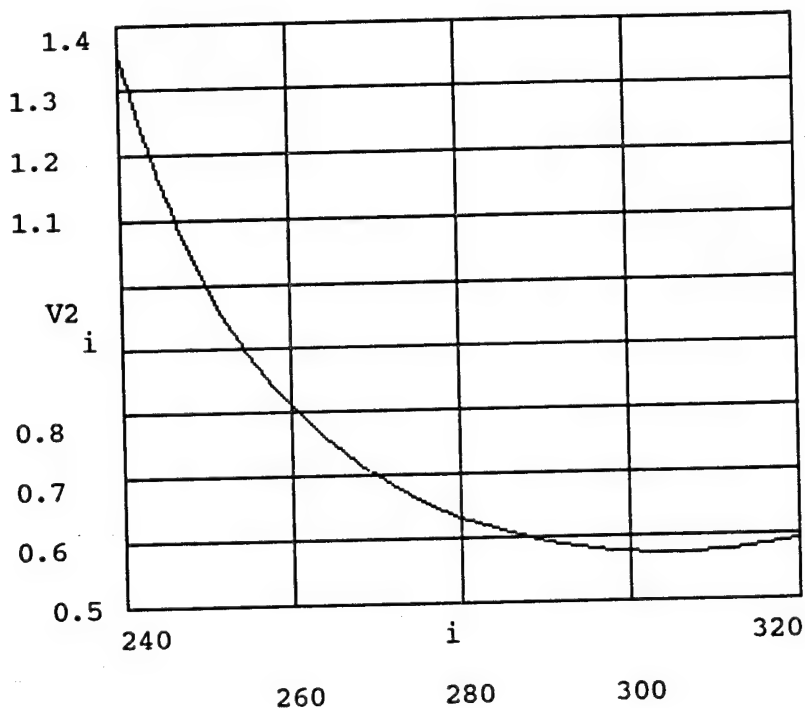
Figure 13-21

From Figure 13-21, $VR = 0.911$

From Figure 13-21, $VR = 0.576$

In this graph, i represents the range of possible impact angles (not striation angles).

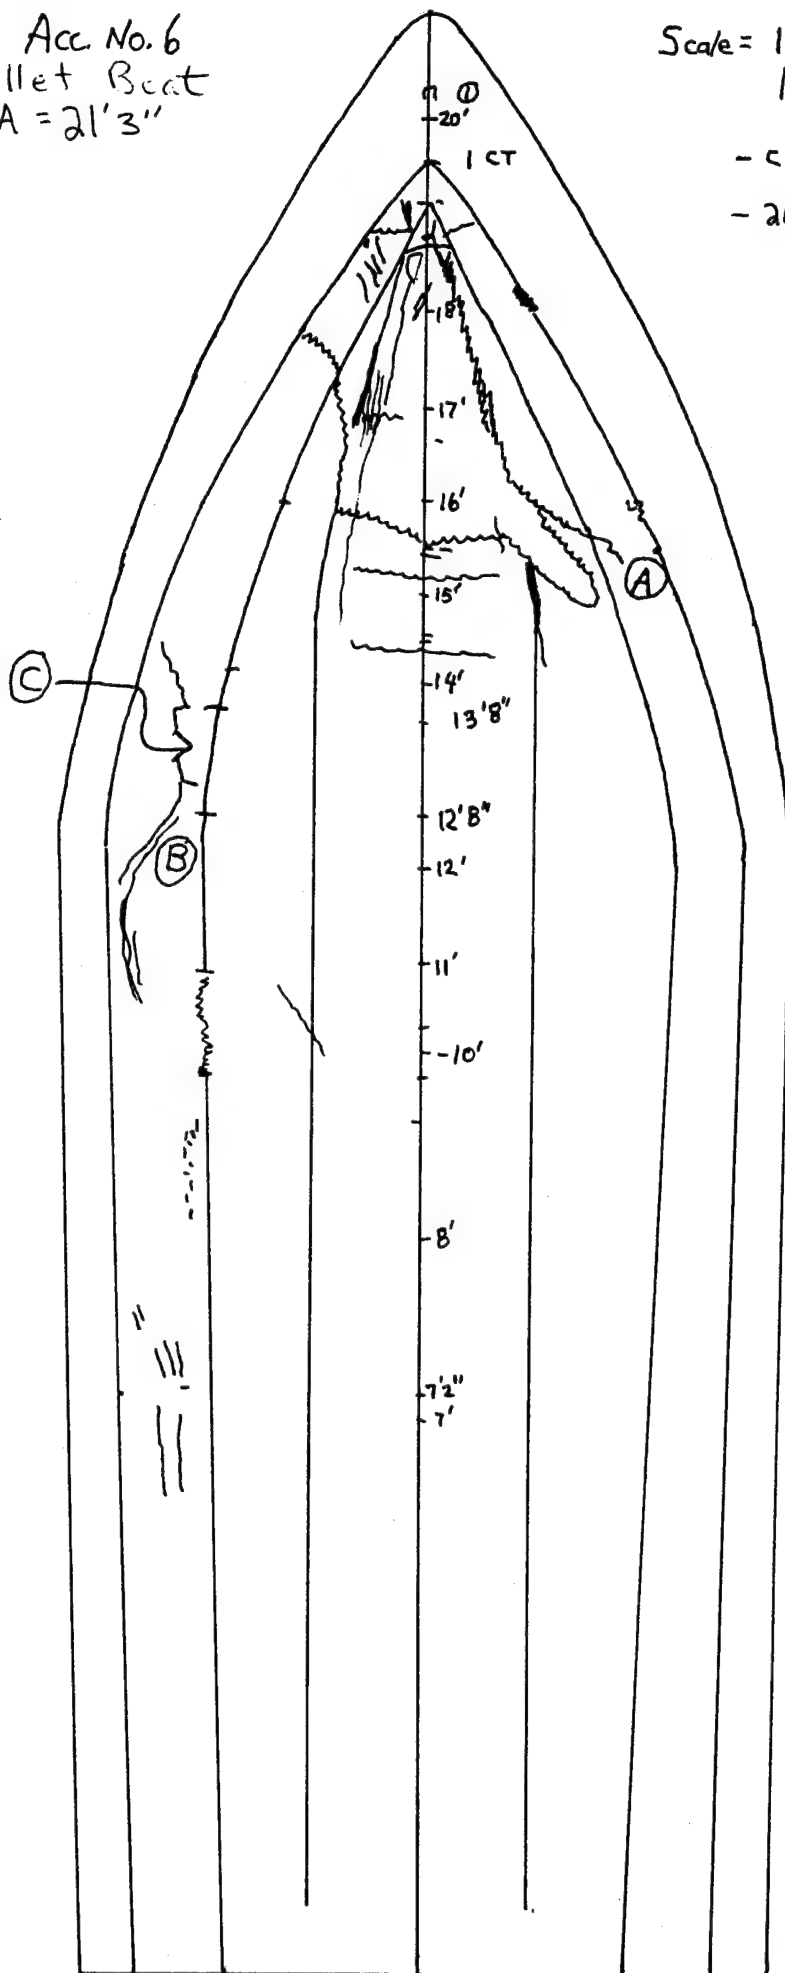
While it is difficult to explain in words alone, the "S" striations located at point B in Figure 13-43 made sense when examined in light of the pivoting hypothesis. If one takes the damage diagrams and maneuvers the boats through the sequence, it becomes more apparent how these marks might have been created as the boat pivots.

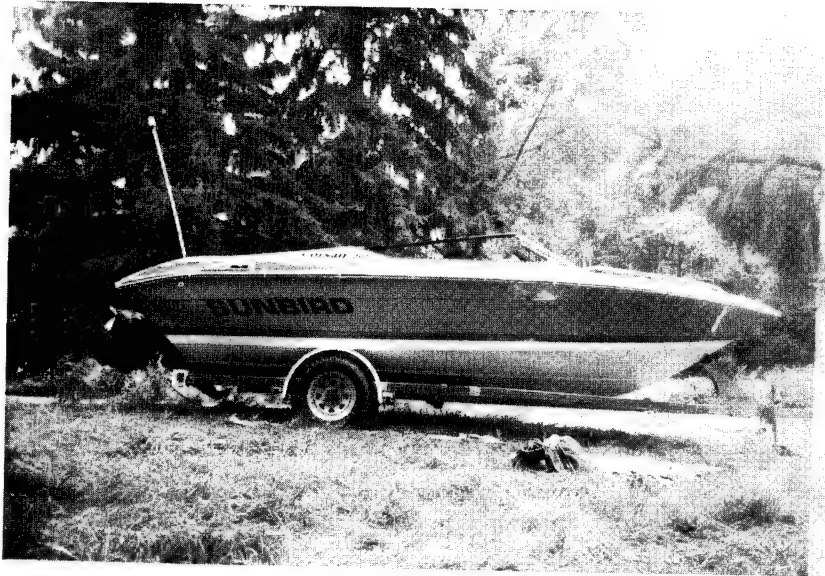
Figure 13-47

A 20 foot I/O open motor boat struck a stationary 21 foot long cuddy cabin cruiser. The boats are shown in Figures 13-47 and 13-48 respectively. The impacting boat struck the cruiser from nearly dead astern and rode completely over the cruiser. Fortunately, no fatalities occurred as a result of this accident.

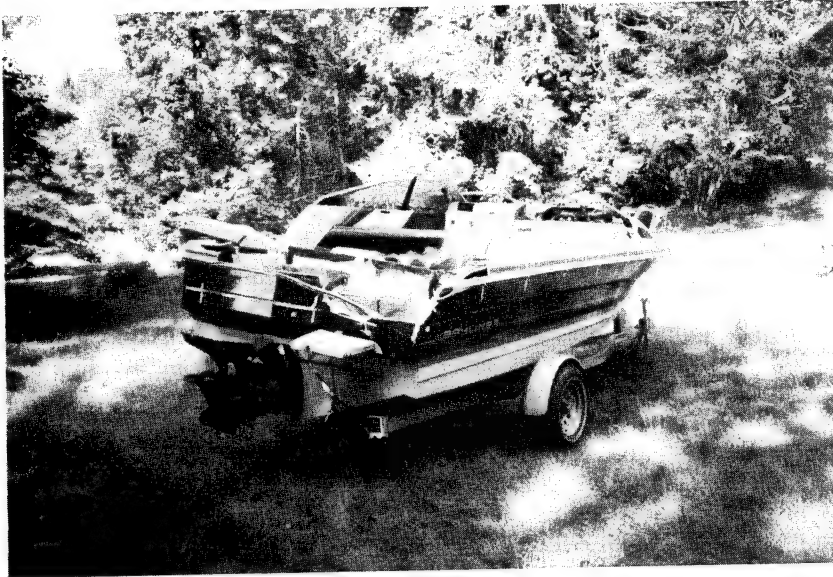
Figure 13-49

The struck boat was struck on the starboard side of the transom. This area is shown in Figure 13-49. The windshield frame on the starboard side of the boat had been severely damaged. The instrument console suffered from an impact either by the bow of the

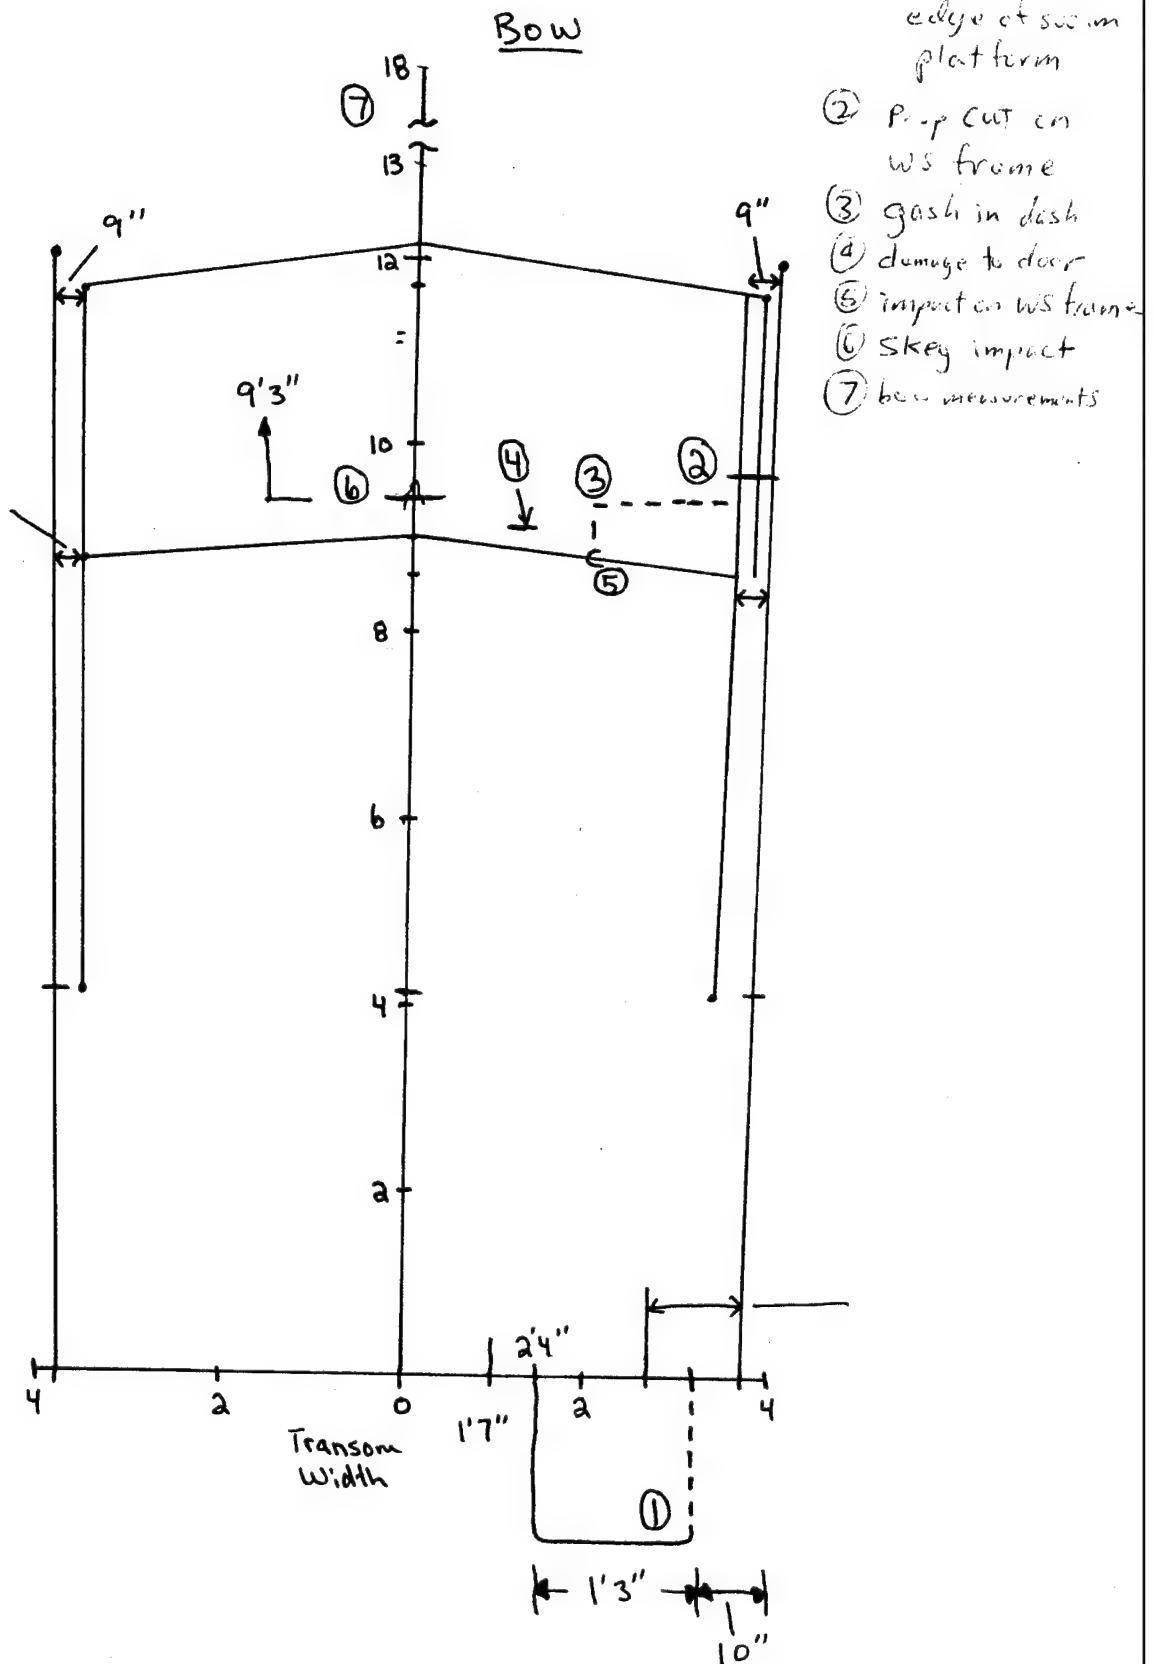
Figure 13-50

boat or the skeg. The windshield frame that ran along the side of the boat, parallel to the centerline, had a single cut in it, transverse to the centerline of the boat. Figures 13-50 and 13-51 are sketches of the damage done to the target boat.

An analysis was conducted to provide speed estimates based on the diagrams in Figure 13-50. The figure number, equation, and the results are presented in the summary that follows.

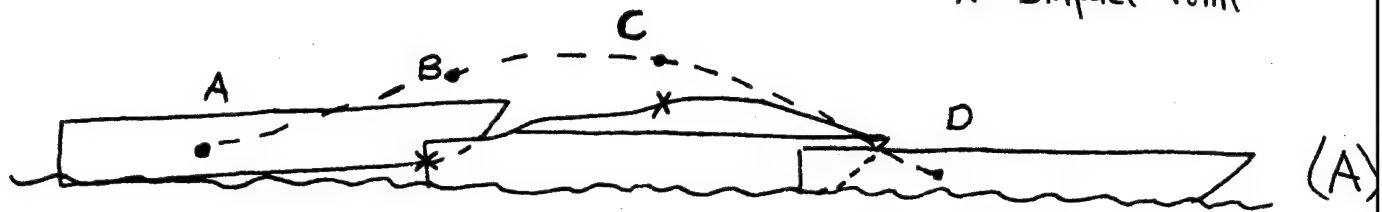
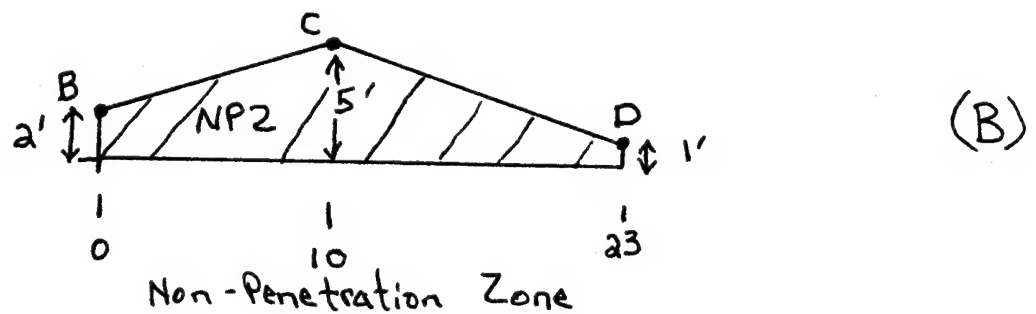
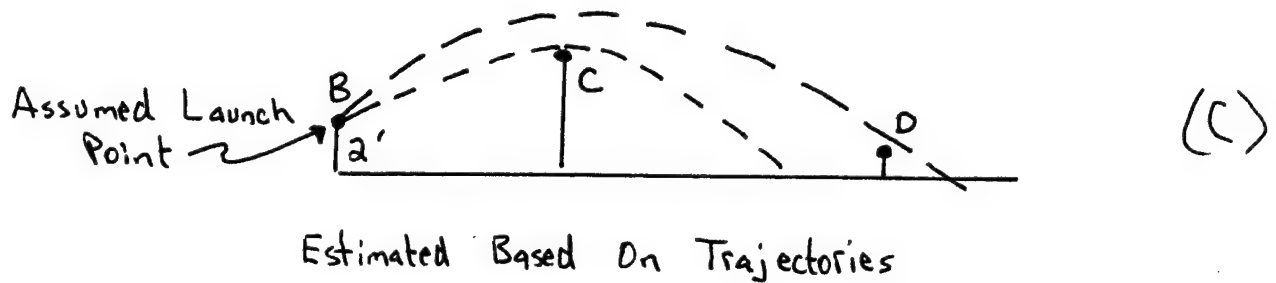
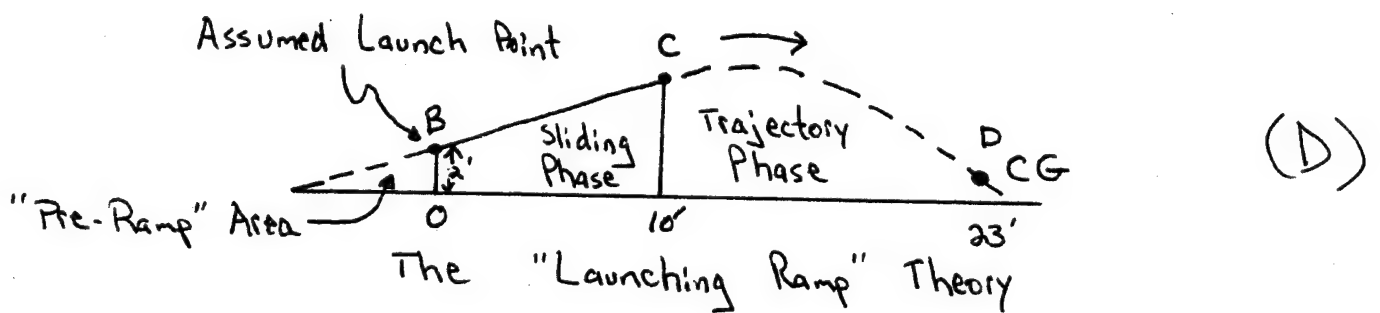
Figure 13-52

Both methods involve determining the area below which the CG could not have fallen during the collision. Figure 13-52a shows how this area was determined for accident number seven. We will refer to this area as the non-penetration zone (NPZ). Parts of the bullet boat will have clearly penetrated the NPZ, but not the CG. Figure 13-52b illustrates a possible NPZ for accident number seven. Obviously, the determination of this area is subjective and depends at least partly upon how much the target boat was depressed during the impact. Note that it is not necessary to know the vertical height of the CG within the bullet boat, since we are only interested in the change in the CG height and not the absolute height.

Method 2A: Now that we have established a NPZ, how do we analyze it? One method is to presume that the launch point of the CG is at or near the impact point, and assume that the rest of the motion can be analyzed as a trajectory motion problem. In certain accidents, this is clearly a reasonable approach when it is known that the bullet boat was essentially launched over the target boat. The appropriate trajectory formulas are selected based on the shape of the NPZ, and provide an estimate of the bullet boat's speed. Figure 13-52c illustrates this method.

The analysis is limited only to the sliding phase of the collision as labeled in Figure 13-52d. The derivation and background for this analysis can be found in Traffic Accident Reconstruction, Volume 2, Topic 862, Section 7. Consult the bibliography for complete information.

The above method needs additional refinement. The actual distance (d) to be used in these equations is open to discussion. This analysis did not consider what is labeled as the "pre-ramp area" in Figure 13-52d.

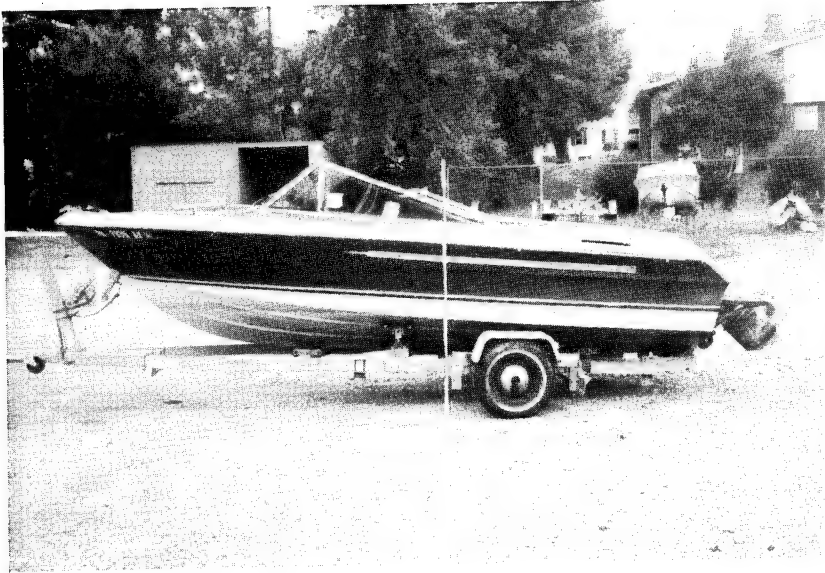
Figure 13-53

A 19 foot I/O traveling at idle speed was struck from the stern by a second vessel at night. The second vessel, in this case the bullet boat, struck the stern, and rode over a portion of the struck boat. The second vessel was released almost immediately after the accident; and therefore, was not available to us for analysis. An overall view of the target boat is shown in Figure 13-53. There were no fatalities in this accident.

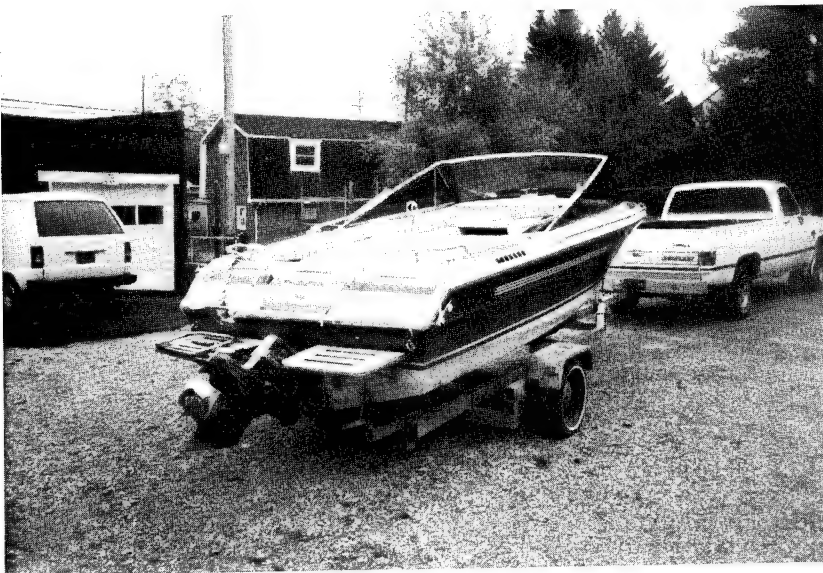
Figure 13-54

Damage to the rear of the boat is shown in Figure 13-54. The damage on the port side of the transom appears to be the point where the lower unit of the bullet boat passed through. If the target boat was traveling very slowly, then this would also be the area where the bow made initial contact. A handrail was crushed on the starboard side of the stern. The side windshield frame on the port side had been lightly struck, showing striations, and slight deformation outward.

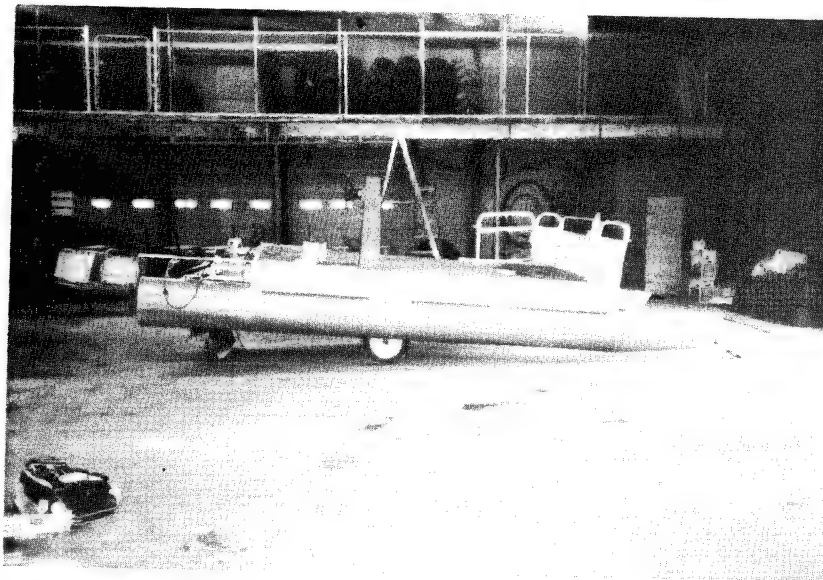
Figure 13-55

A 20 foot I/O open motorboat struck a 20 foot pontoon boat powered by a 40 HP outboard motor. The motorboat struck the pontoon boat on the port quarter and rode over the boat, exiting the starboard side near the stern. The pontoon boat carried nine passengers. Two were killed, and three were injured. Three occupants were on board the motorboat, one of which suffered minor injuries. The occupants on board the motorboat said that the jolt was fairly minor, as if they had run over a log. The port pontoon was punctured by the motorboat, and quickly filled with water. The pontoon boat then quickly capsized. An overall view of the pontoon boat and the motorboat are shown in Figures 13-55 and 13-56 respectively. The primary questions in this accident were as follows:

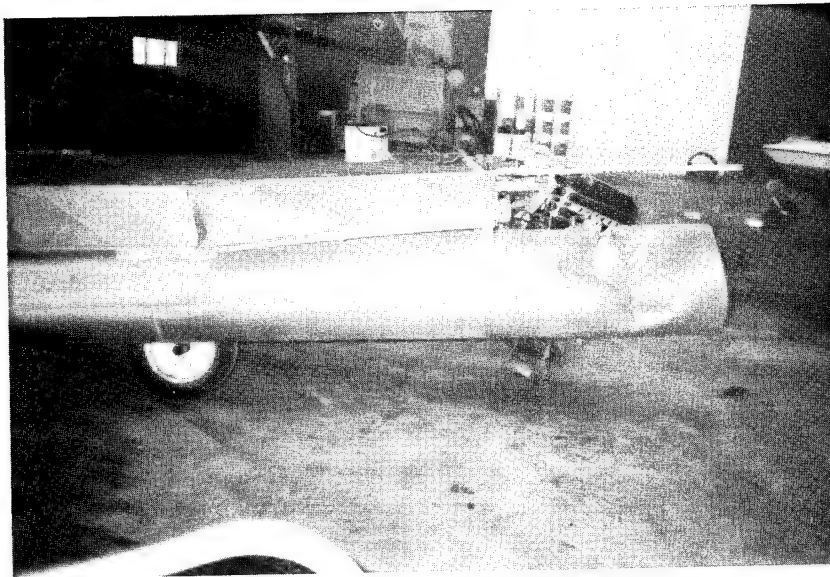
Figure 13-57 and 13-58 show the damage to the port quarter of the pontoon boat. Damage to the pontoon caused by the outdrive and propeller is clearly visible on the port pontoon. This is probably the most obvious example of damage matching. The propeller of the boat clearly caused this damage.

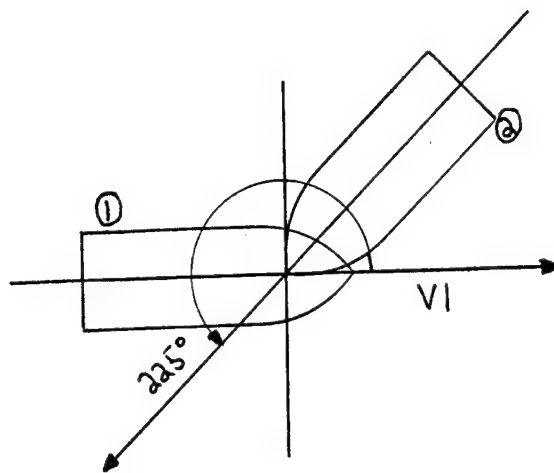
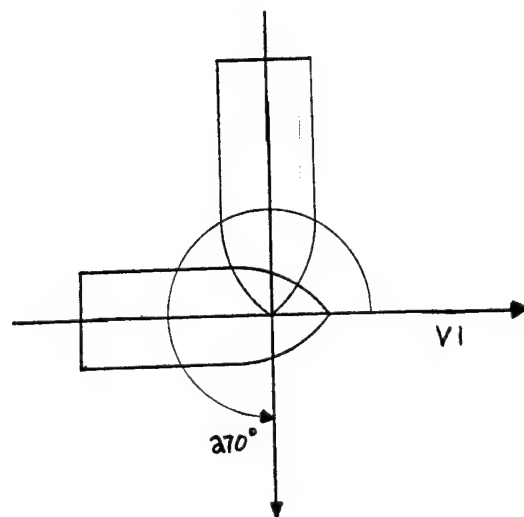
Figure 13-72

Possible Impact Angle for Accident No. 10. The Vector Impact Angles Range From Approximately 225° to 270° .

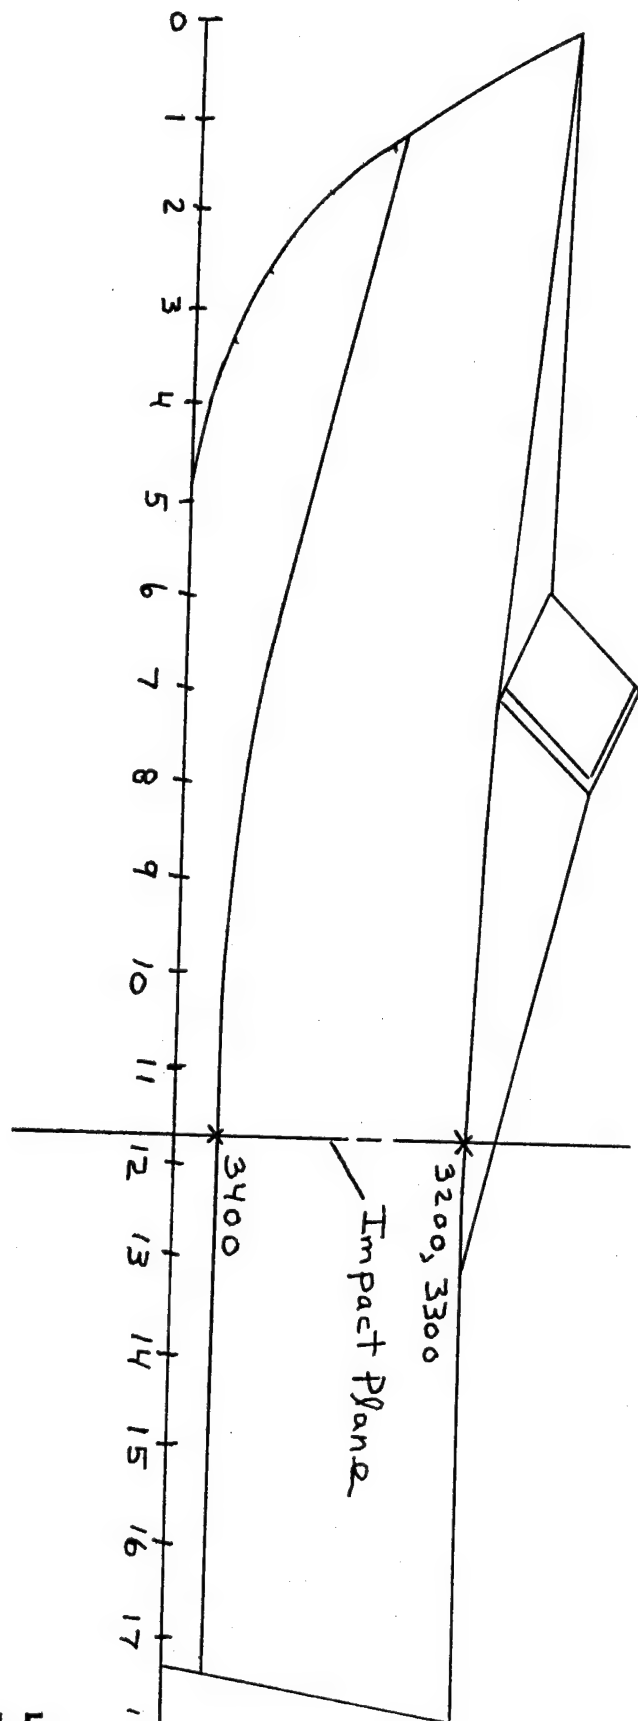
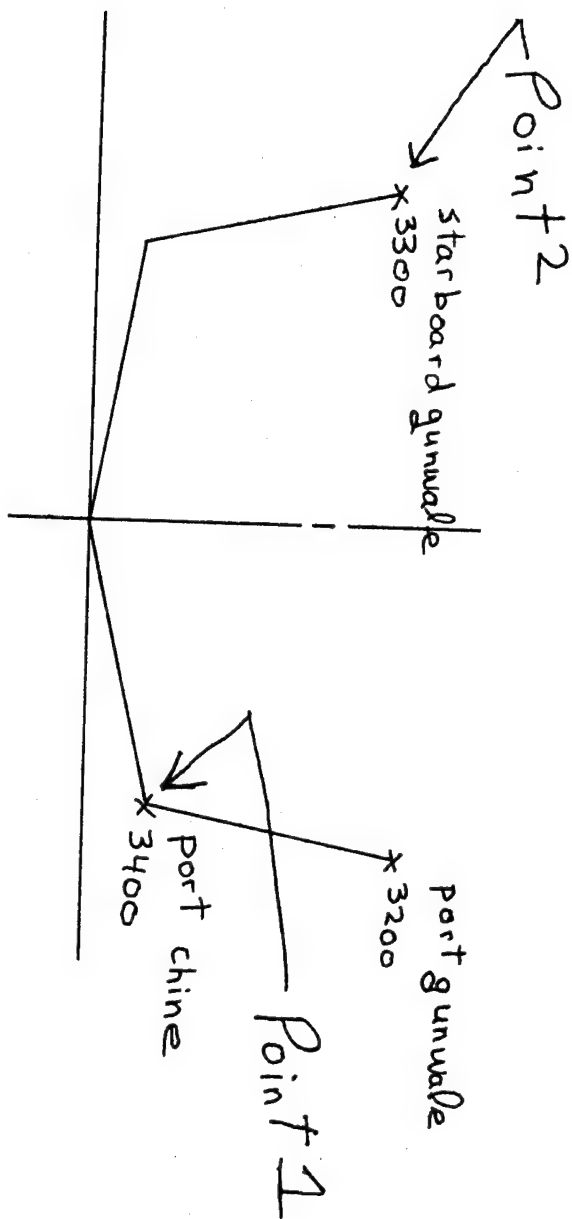
Even though much of the hull material on the struck side is damaged or swept away, the dynamics of the collision are largely determined by two hard points on the vessel. Choosing the proper location of these hard points was critical to the success of the collision. The diagram in Figure 14-5 illustrates this point. Points 1 and 2 represent the locations chosen for these hardpoints.

Target Boat Geometry for
the Collision Analysis.

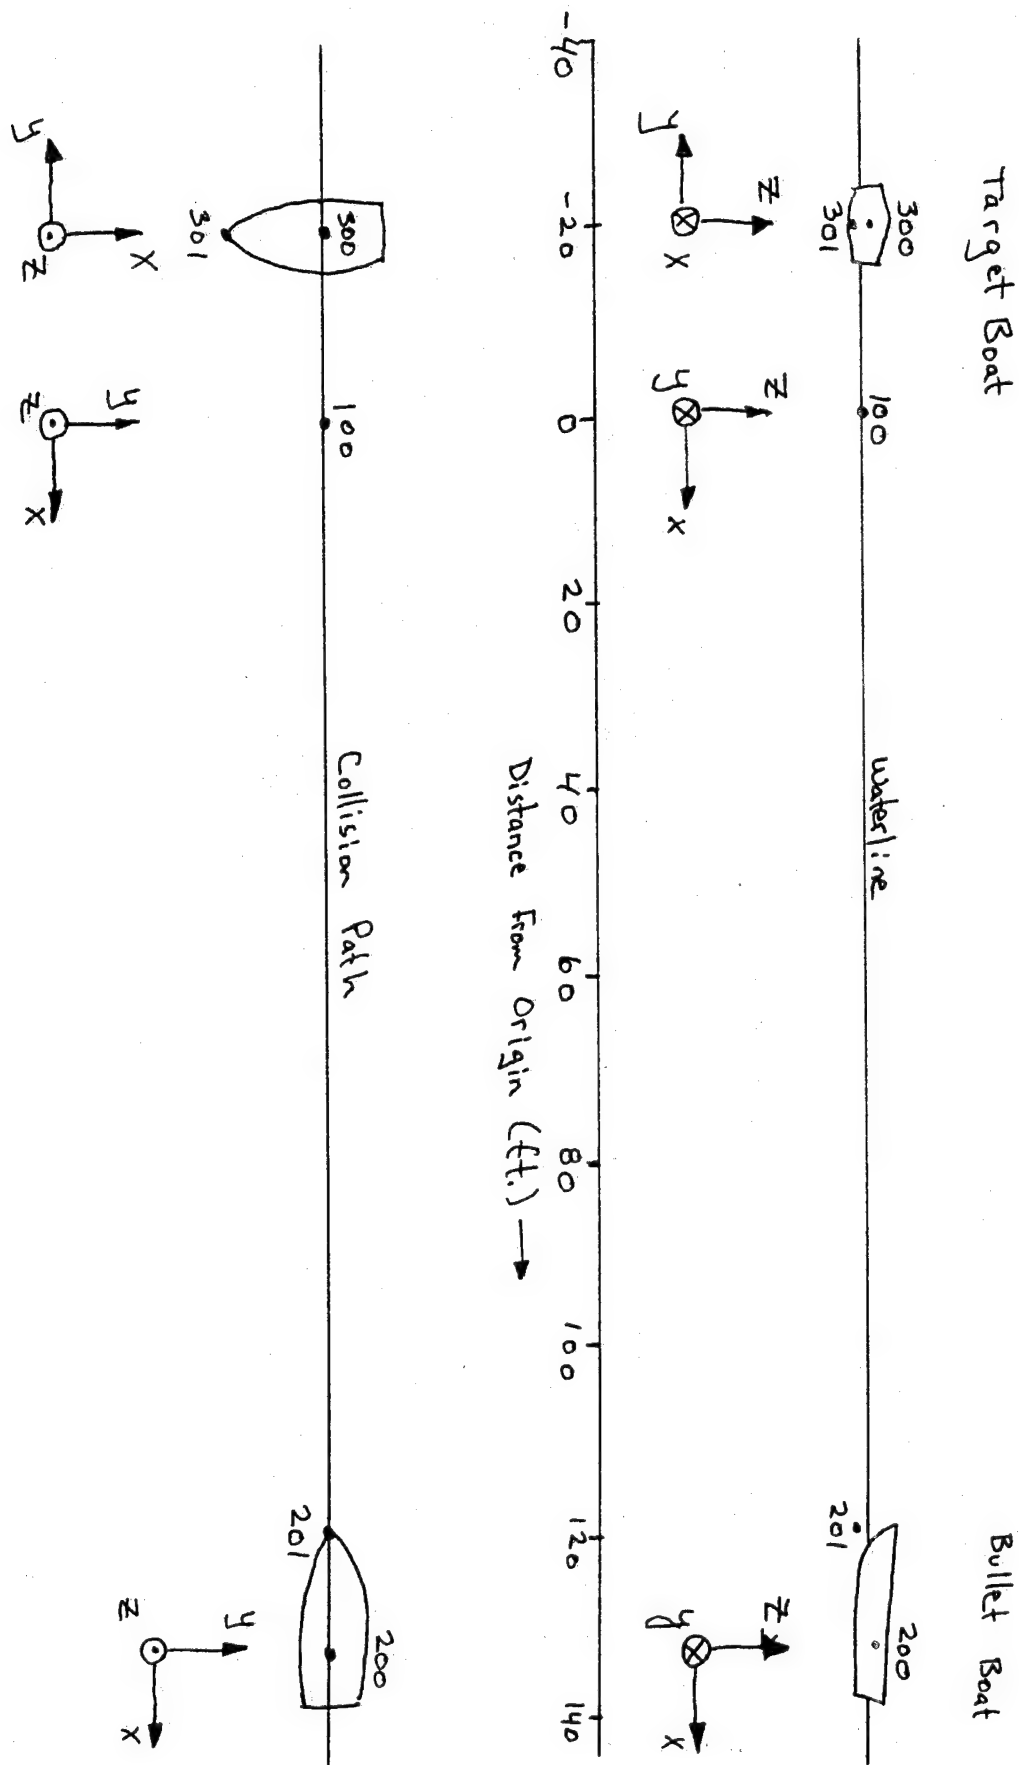
Figure 14-6 shows the overall geometry of the collision scene at the beginning of the simulation run. Five important markers are included in this figure. Marker number 100 is a fixed reference point, located on the surface of the water in line with the path of the bullet boat. This point serves as the global origin for the simulation. Markers 200 and 201 are fixed relative to part number 2 (the bullet boat). Markers 300 and 301 are fixed relative to part number 3 (the target boat). Markers 200 and 300 are identified in the respective part 2 and part 3 statements as center of mass markers. Markers 201 and 301 are positioned directly under the bow points of the boats, on the extension of the keel lines, as shown in Figure 14-5.

Basic Geometry of the 30 mph Collision.

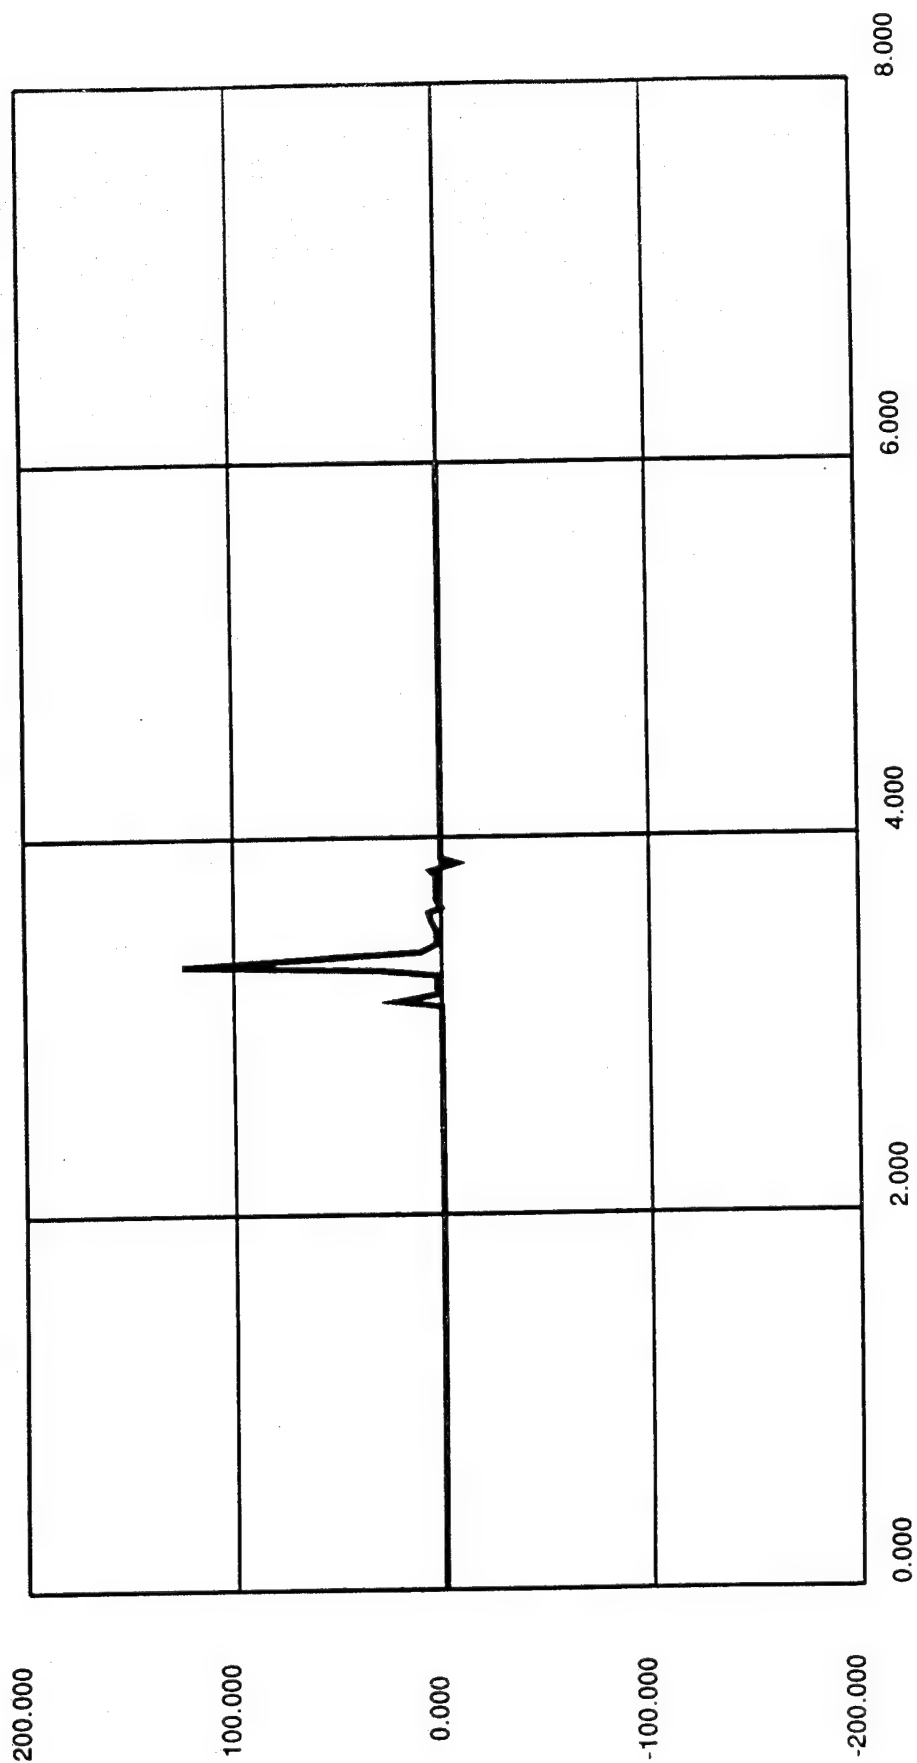
Figure 14-12 and 14-13 show the accelerations for the bullet boat in the x and z axis respectively. The units are given in ft/sec². Note that the plot for the z axis shows the pre-impact accelerations at approximately zero. Thus the values obtained from the graph for the z axis must have the component of acceleration due to gravity added for our analysis. This must be done since we are really interested in the forces on the occupants, as calculated from $F = ma$. Thus, components of acceleration for the z axis expressed in feet/per second² will have the value of 32.2 added to them. When acceleration is expressed in g's, the force on an object can be calculated by multiplying this number times the weight of the object. If this sounds confusing, think of the force between the person and the boat if the boat were suddenly allowed to accelerate downward at 32.2 ft/sec/sec. The contact force would be zero! However, if the same boat were suddenly accelerated upward at 32.2 ft/sec/sec, the contact force between the occupant the boat would be two times the occupant weight. Thus, a person weighing 150 lbs would exert a force of 300 lbs on the boat.

Req 2003, Col 1, Bullet Boat Acceleration $\left(\frac{ft}{sec^2}\right)$
